Hill of Fare Wind Farm

Technical Appendix 14.2

Detailed Unexploded Ordnance Risk Assessment

Detailed Unexploded Ordnance (UXO) Risk Assessment

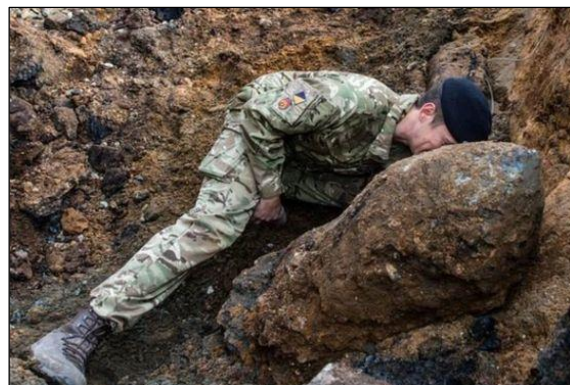
Top: J-curve Effect - Due to angle of entry, unexploded bombs would often end their trajectory at a lateral offset from point of entry, often ending up beneath adjacent extant structures/sites. The photograph above shows 250kg bomb found in Bermondsey pointing upwards, demonstrating 'J-curve'

J-curve is the term used to describe the characteristic curve commonly followed by an aerial delivered bomb dropped from height after it penetrates the ground. Typically, as the bomb is slowed by its passage through underlying soils, its trajectory curves towards the surface. Many UXBs are found with their nose cone pointing upwards as a result of this effect. More importantly, however, is the resulting horizontal offset from the point of entry. This is typically a distance of about one third of the bomb's penetration depth, but can be higher in certain conditions (see **Annex E**).

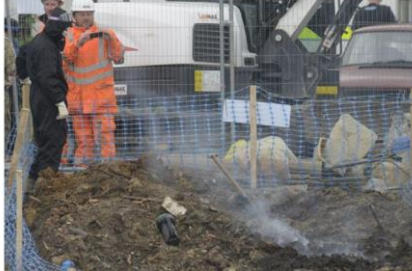
The scene at Blacksole Bridge after wartime explosives were found in the railway cutting

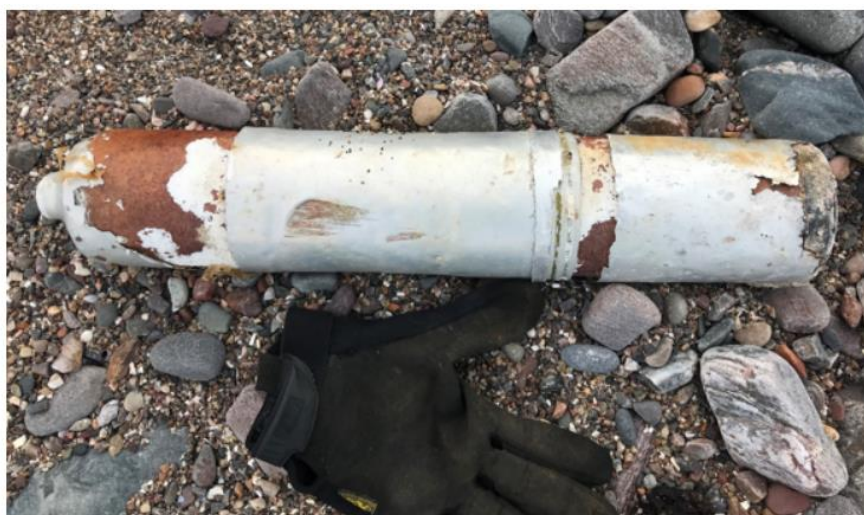
Pictures have now revealed that a two-inch mortar had washed ashore at the beach, along with some other suspected munitions from the Second World War such as a possible floating smoke candle – which were designed to be used to screen amphibious forces.

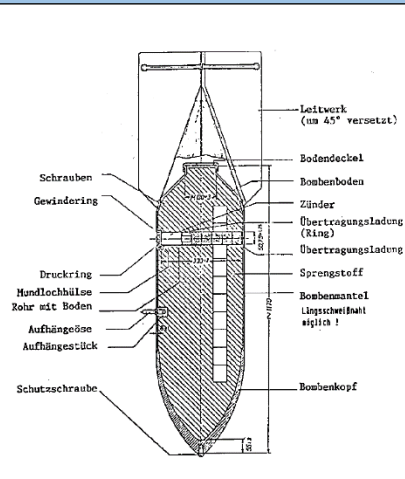
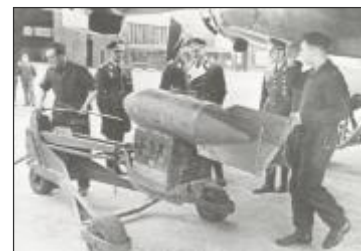
SC 250kg	
Bomb Weight	245-256kg (540-564lb)
Explosive Weight	125-130kg (276-287lb)
Fuze Type	Electrical impact/mechanical time delay fuze.
Bomb Dimensions	1640 x 512mm (64.57 x 20.16in)
Body Diameter	368mm (14.5in)
Use	Against railway installations, embankments, flyovers, underpasses, large buildings and below-ground installations.
Remarks	It could be carried by almost all German bomber aircraft, and was used to notable effect by the Junkers Ju-87 Stuka (Sturzkampfflugzeug or dive-bomber).

Labels: Leitwerk (na 45° versetzt), Schrauben, Gewindering, Druckring, Mundlochhülse, Rohr mit Boden, Aufhängeöse, Aufhängestück, Schutzschraube, Bombenboden, Zünder, Übertragungsladung (Ring), Sprengstoff, Bombenmantel, Längsschnittball sigilla!, Bombenkopf

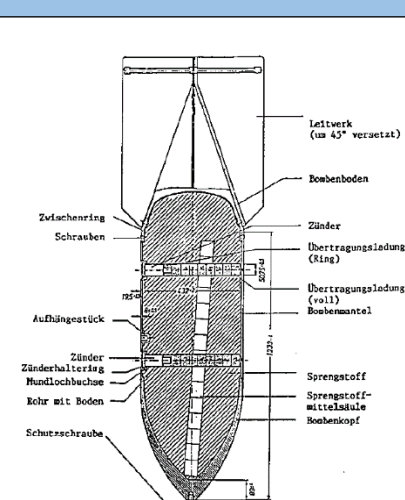
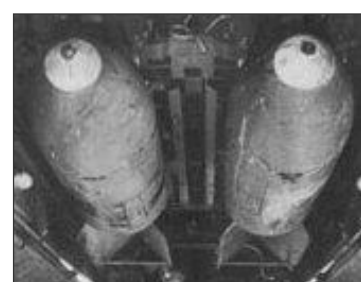
SC 500kg	
Bomb Weight	480-520kg (1,058-1,146lb)
Explosive Weight	250-260kg (551-573lb)
Fuze Type	Electrical impact/mechanical time delay fuze.
Bomb Dimensions	1957 x 640mm (77 x 25.2in)
Body Diameter	470mm (18.5in)
Use	Against fixed airfield installations, hangars, assembly halls, flyovers, underpasses, high-rise buildings and below-ground installations.
Remarks	40/60 or 50/50 Amatol TNT, trialene. Bombs recovered with Trialene filling have cylindrical paper wrapped pellets 1-15/16 in. in length and diameter forming

Labels: Leitwerk (na 45° versetzt), Bombenboden, Zwischenring, Schrauben, Aufhängestück, Zünder, Zünderhaltering, Mundlochbechse, Rohr mit Boden, Schutzschraube, Zünder, Übertragungsladung (Ring), Sprengstoff, Sprengstoff-mittelsäule, Bombenmantel, Bombenkopf

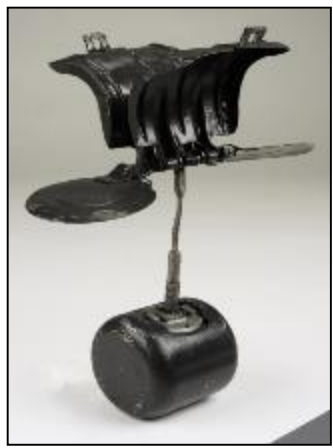
SD2 Butterfly Bomb	
Bomb Weight	2kg (4.41lb)
Explosive Weight	7.5oz (212.6 grams) of TNT surrounded by a layer of bituminous composition.
Fuze Type	41 fuze (time) , 67 fuze (clockwork time delay) or 70 fuze (anti-handling device)
Bomb Dimensions	Length 240 mm Width 140 mm Height 310 mm
Body Diameter	3in (7.62 cm) diameter, 3.1in (7.874) long
Use	It was designed as an anti-personnel/fragmentation weapon. They were delivered by air, being dropped in containers that opened at a predetermined height, thus scattering the bombs.
Remarks	The smallest and most common conventional German bomb. Nearly 70% of bombs dropped on the UK were 50kg.

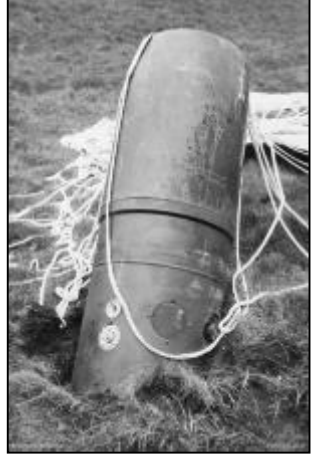
Parachute Mine (Luftmine B / LMB)	
Bomb Weight	987.017kg (2176lb)
Explosive Weight	125-130kg (276-287lb)
Fuze Type	Impact/ Time delay / hydrostatic pressure fuze
Bomb Dimensions	1640 x 512mm (64.57 x 20.16in)
Body Diameter	368mm (14.5in)
Use	Against civilian, military and industrial targets. Designed to detonate above ground level to maximise damage to a wider area.
Remarks	Parachute Mines were normally carried by HE 115 (Naval operations), HE 111 and JU 88 aircraft types. Deployed a parachute when dropped in order to control its descent.

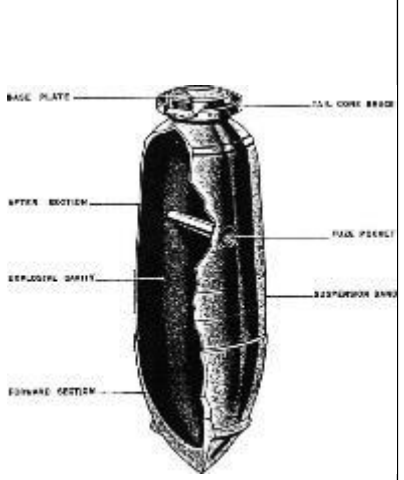
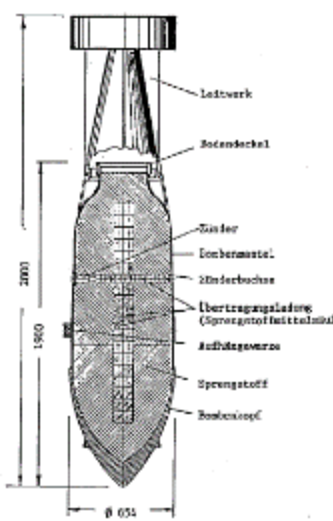
SC 1000kg	
Bomb Weight	996-1061kg (1,058-1,146lb)
Explosive Weight	530-620kg (551-573lb)
Fuze Type	Electrical impact/mechanical time delay fuze.
Filling	Mixture of 40% amatol and 60% TNT, but when used as an anti-shipping bomb it was filled with Trialen 105, a mixture of 15% RDX, 70% TNT and 15% aluminium powder.
Bomb Dimensions	2800 x 654mm (77 x 25.2in)
Body Diameter	654mm (18.5in)
Use	SC type bombs are General Purpose Bombs used primarily for general demolition work. Constructed of parallel walls with comparatively heavy noses. They are usually of three piece welded construction

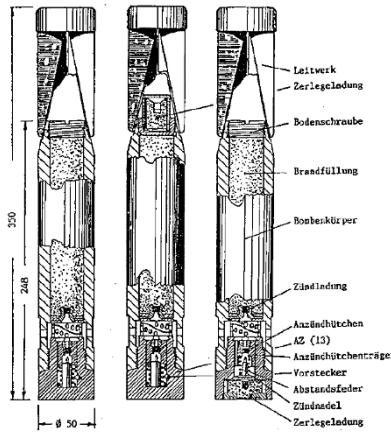
1kg Incendiary Bomb	
Bomb Weight	1.0 and 1.3kg (2.2 and 2.87lb)
Explosive Weight	680gm (1.3lb) Thermit
Fuze Type	Impact fuze
Bomb Dimensions	350 x 50mm (13.8 x 1.97in)
Body Diameter	50mm (1.97in)
Use	As incendiary – dropped in clusters against towns and industrial complexes
Remarks	Magnesium alloy case. Sometimes fitted with high explosive charge. The body is a cylindrical alloy casting threaded internally at the nose to receive the fuze holder and fuze.

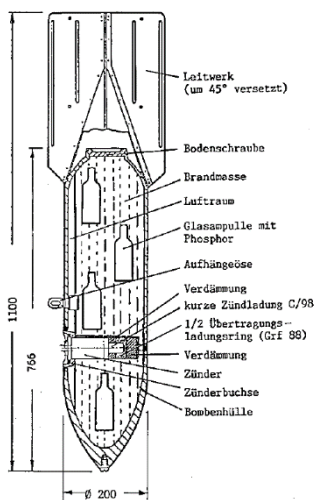
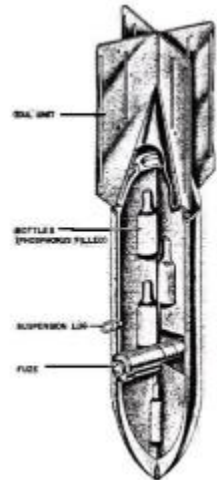
C50 A Incendiary Bomb	
Bomb Weight	c41kg (90.4lb)
Explosive Weight	0.03kg (0.066lb)
Incendiary Filling	12kg (25.5lb) liquid filling with phosphor igniters in glass phials. Benzine 85%; Phosphorus 4%; Pure Rubber 10%
Fuze Type	Electrical impact fuze
Bomb Dimensions	1,100 x 280mm (43.2 x 8in)
Use	Against all targets where an incendiary effect is to be expected
Remarks	Early fill was a phosphorous/carbon disulphide incendiary mixture

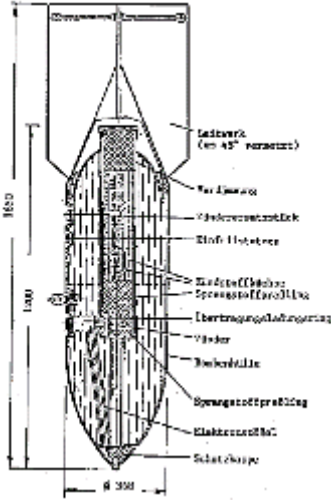
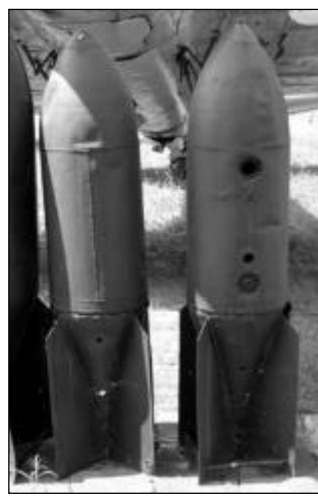
Flam C-250 Oil Bomb	
Bomb Weight	125kg (276lb)
Explosive Weight	1kg (2.2lb)
Fuze Type	Super-fast electrical impact fuze
Filling	Mixture of 30% petrol and 70% crude oil
Bomb Dimensions	1,650 x 512.2mm (65 x 20.2in)
Body Diameter	368mm (14.5in)
Use	Often used for surprise attacks on living targets, against troop barracks and industrial installations. Thin casing – not designed for ground penetration

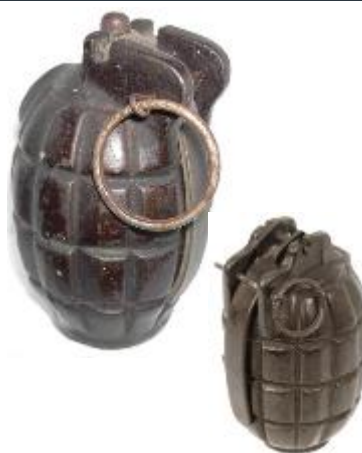
Weight	760g filled (1lb 6oz)
Explosive Weight	71g (2.5 oz) Baratol filling.
Fuze Type	4 second delay hand-throwing fuze
Dimensions	95 x 61mm (3.7 x 2.4in)
Use	Fragmentation explosive at approx. 30m range 100m range of damage.
Remarks	First introduced in 1915 its classic grooved 'pineapple' design was designed to provide uniform fragmentation. Approx. over 70million were produced.

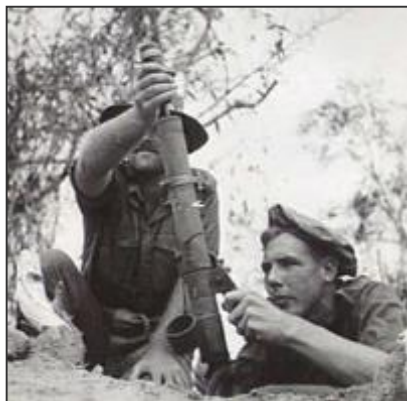
Weight	1.02kg (2.25lb)
Maximum Range	460m (500yards)
Filling	200g RDX/TNT
Dimensions	51 x 290mm (2in x 11.4 in)
Fuze Type	An impact fuze which detonates the fuze booster charge and in turn the high explosive charge.
Use	A small, portable mortar introduced into the British army in 1938. It had greater range and firepower over hand and rifle grenades, and was used to attack targets behind cover with high explosive rounds.
Remarks	Detonation causes the mortars bomb body to shatter producing optimum fragmentation and blast effect at the target.

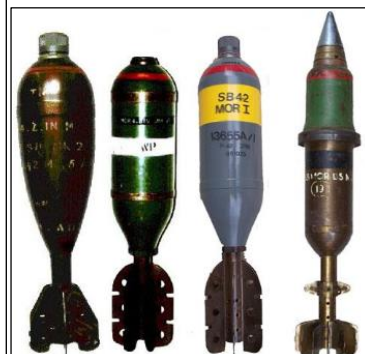
ML 4.2 inch Mortar

Weight	9kg (19lb 13oz)
Maximum Range	3,750m (4,100 yards)
Filling	High explosive, smoke (white phosphorous or Titanium Tetrachloride) or chemical
Bomb Dimensions	500 x 105 mm (19 in x 4 in)
Fuze Type	Sensitive fuze with HE bursting charge.
Use	A widely used heavy motor which first saw use in 1942 and saw usage throughout the post-war period.
Remarks	Different markings denoted different fillings. See image to the right.

L to R: HE, Smoke, Chemical, Smoke BE.

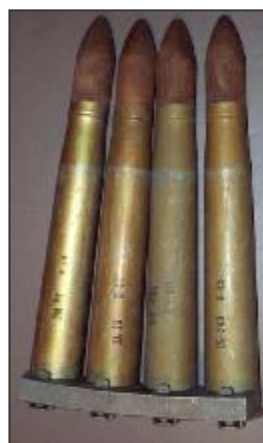
40mm Bofors Projectile

Projectile Weight	1.96lb (0.86kg)
Explosive Weight	300g (0.6lb)
Fuze Type	Proximity and Mechanical Time Fuze
Rate of Fire	120 rounds per minute
Projectile Dimensions	40mm x 310mm (1.6in x 12.2in)
Ceiling	23,000ft (7000m)

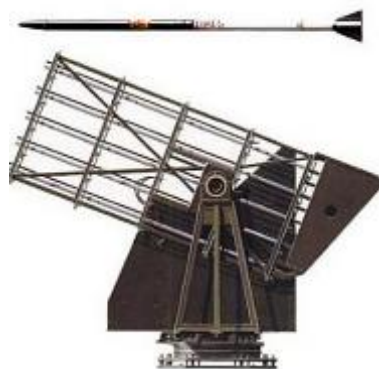
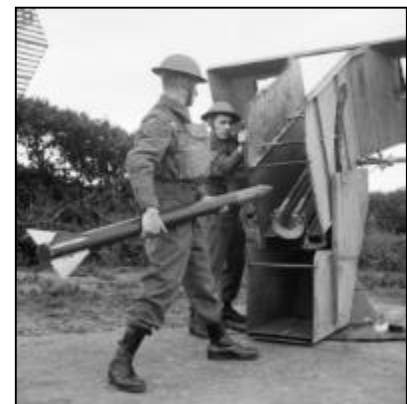
Unrotated Projectile (UP) – Z Battery

Projectile Weight	84lb (24.5kg)
Warhead Weight	4.28lb (1.94kg)
Warhead	Aerial Mine with a No. 700 / 720 fuze
Filling	High Explosive
Dimensions	1930mm x 82.6mm (76 x 3.25in)
Use	As a short range rocket-firing anti-aircraft weapon developed for the Royal Navy. It was used extensively by British ships during the early days of World War II. The UP was also used in ground-based single and 128-round launchers known as Z Batteries.
